CONFEDERACIÓN  
HIDROGRÁFICA  
DEL EBRO

# INFORME DEL COMPORTAMIENTO DE LA LADERA DERECHA DE LA PRESA DE YESA (NAVARRA). NOVIEMBRE 2015

Zaragoza noviembre de 2015

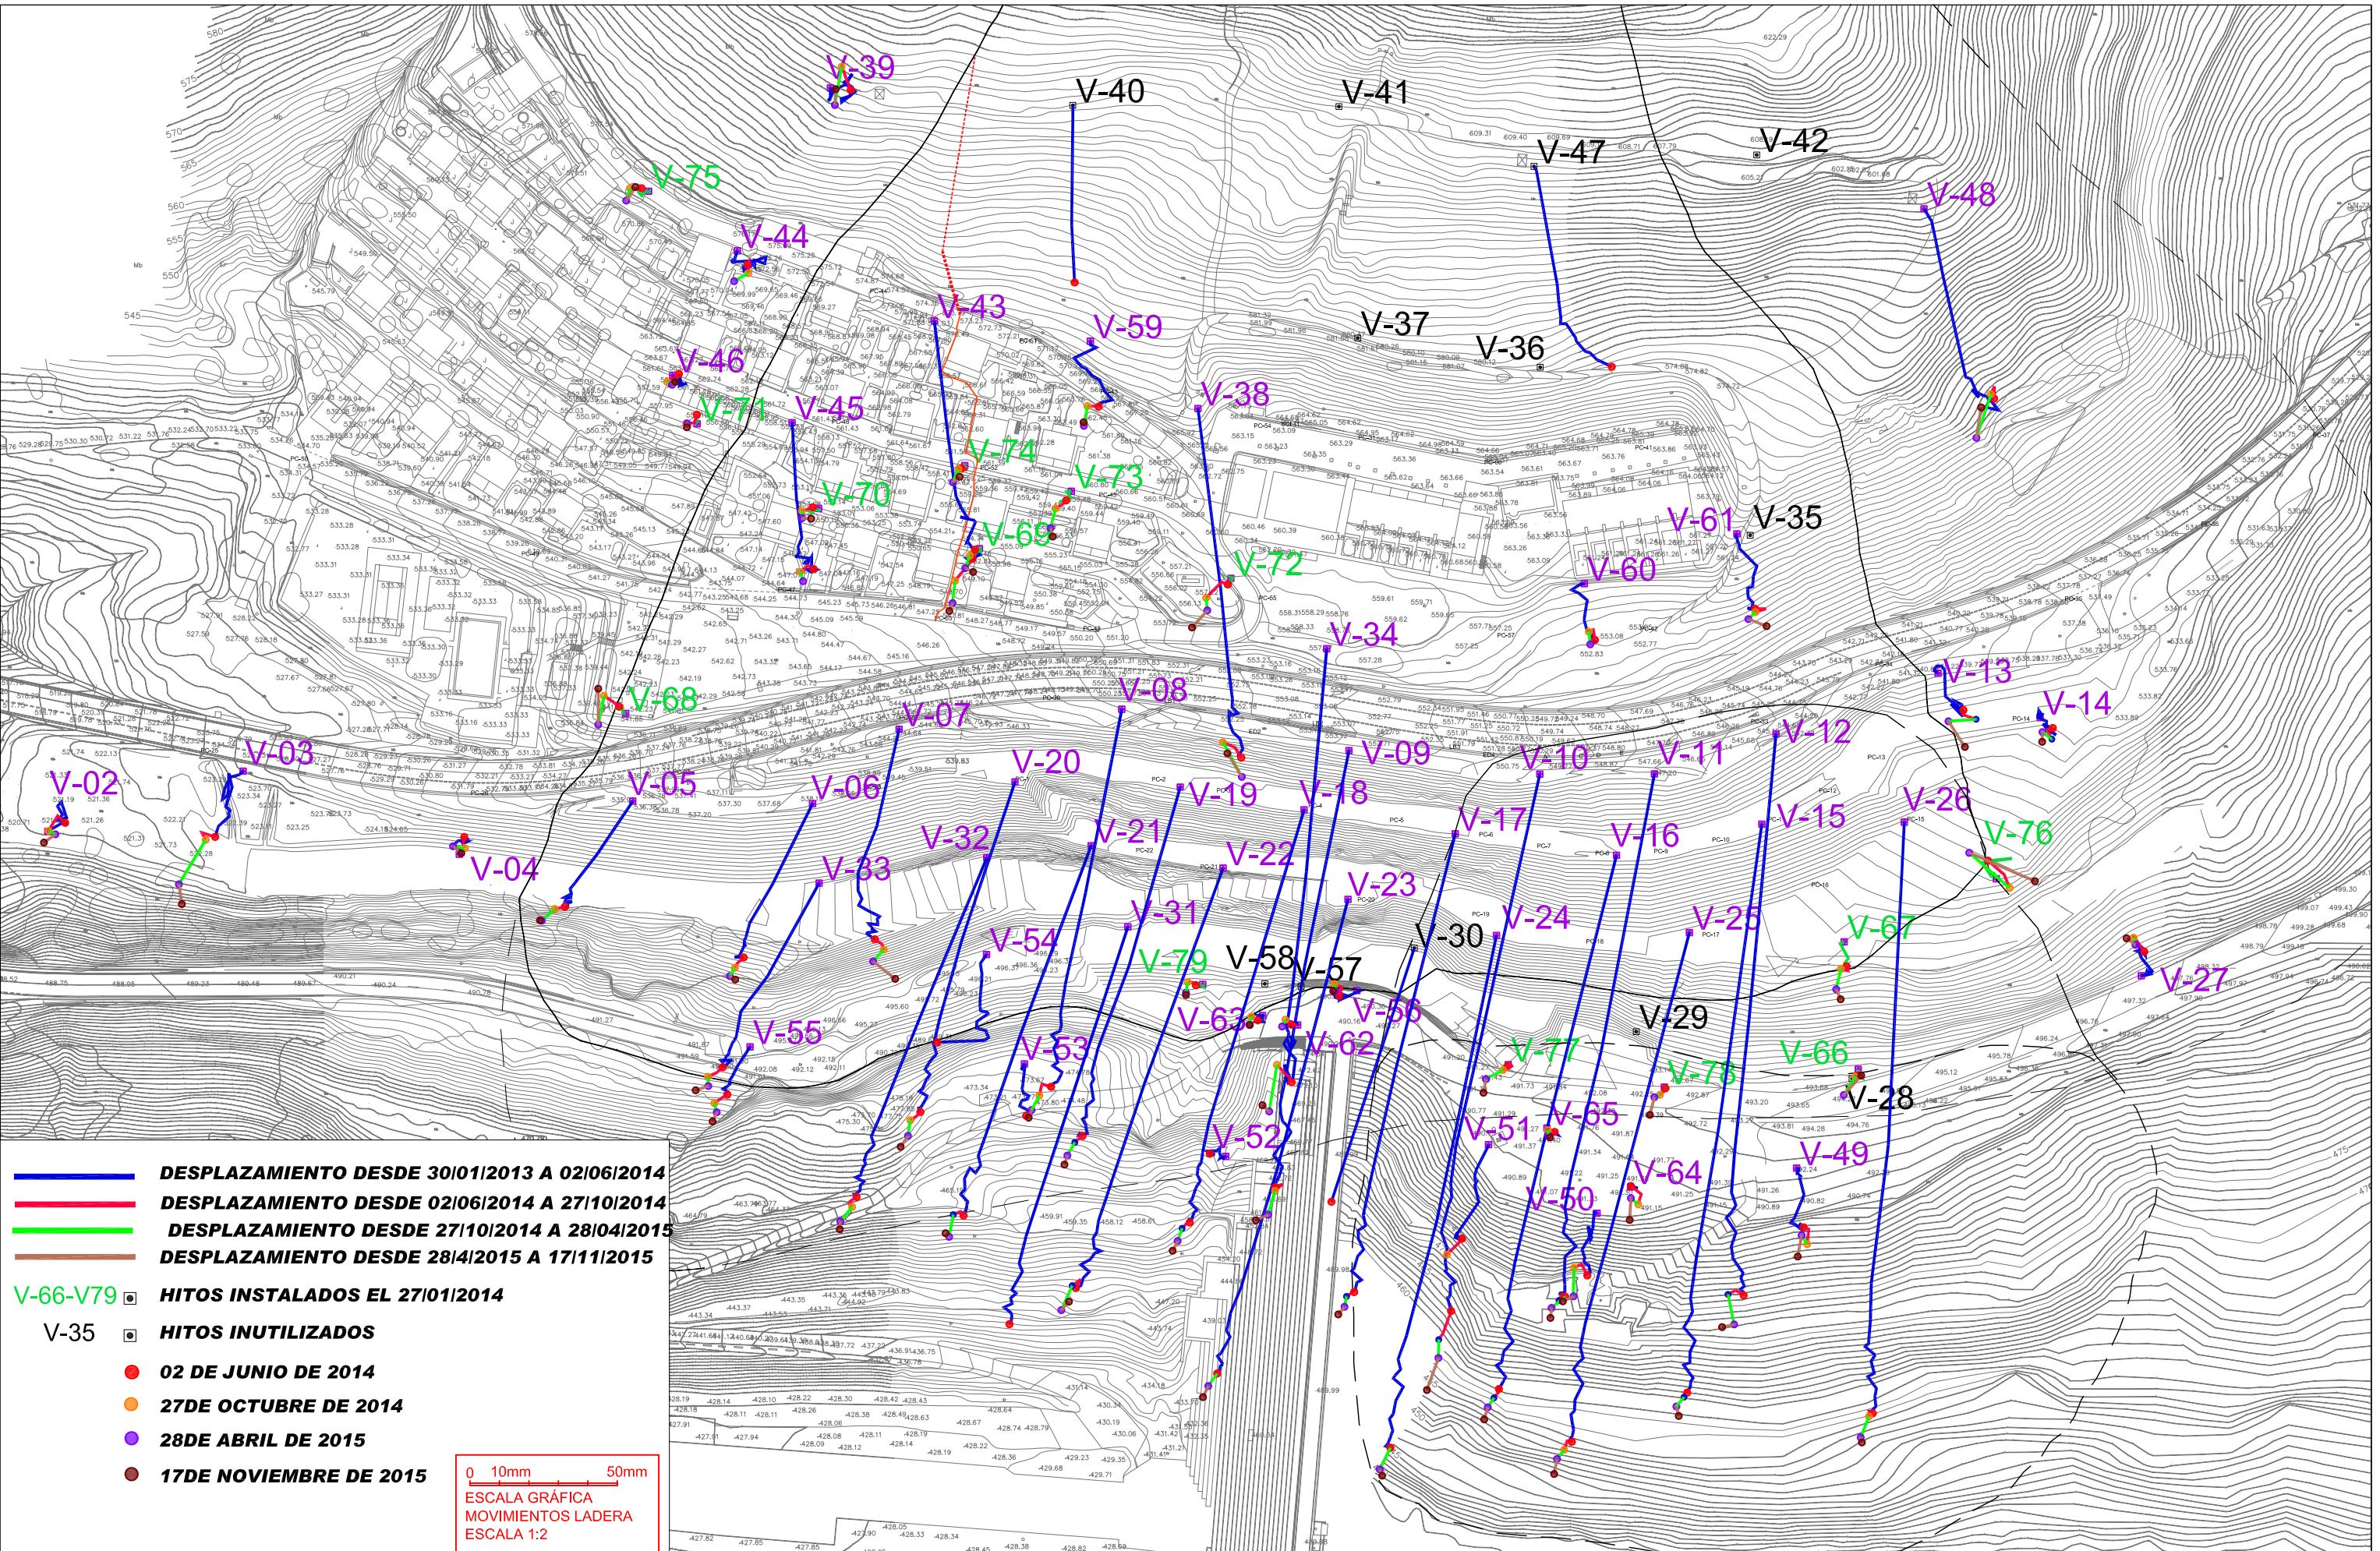
**ANEJO Nº 1:**  
**Plano de movimiento de los Puntos de Control Topográfico.**

El movimiento de estos puntos tiene un máximo de 18,2 mm/año (periodo comprendido entre 17/11/2014 y 17/11/2015) correspondiente al punto V-10, siendo el menor de ellos de 2,5 mm/año (considerado como umbral inferior).
