CONFEDERACIÓN
HIDROGRÁFICA
DEL EBRO

INFORME DEL COMPORTAMIENTO DE LA LADERA DERECHA DE LA PRESA DE YESA (NAVARRA). MAYO 2018

Zaragoza, junio de 2018

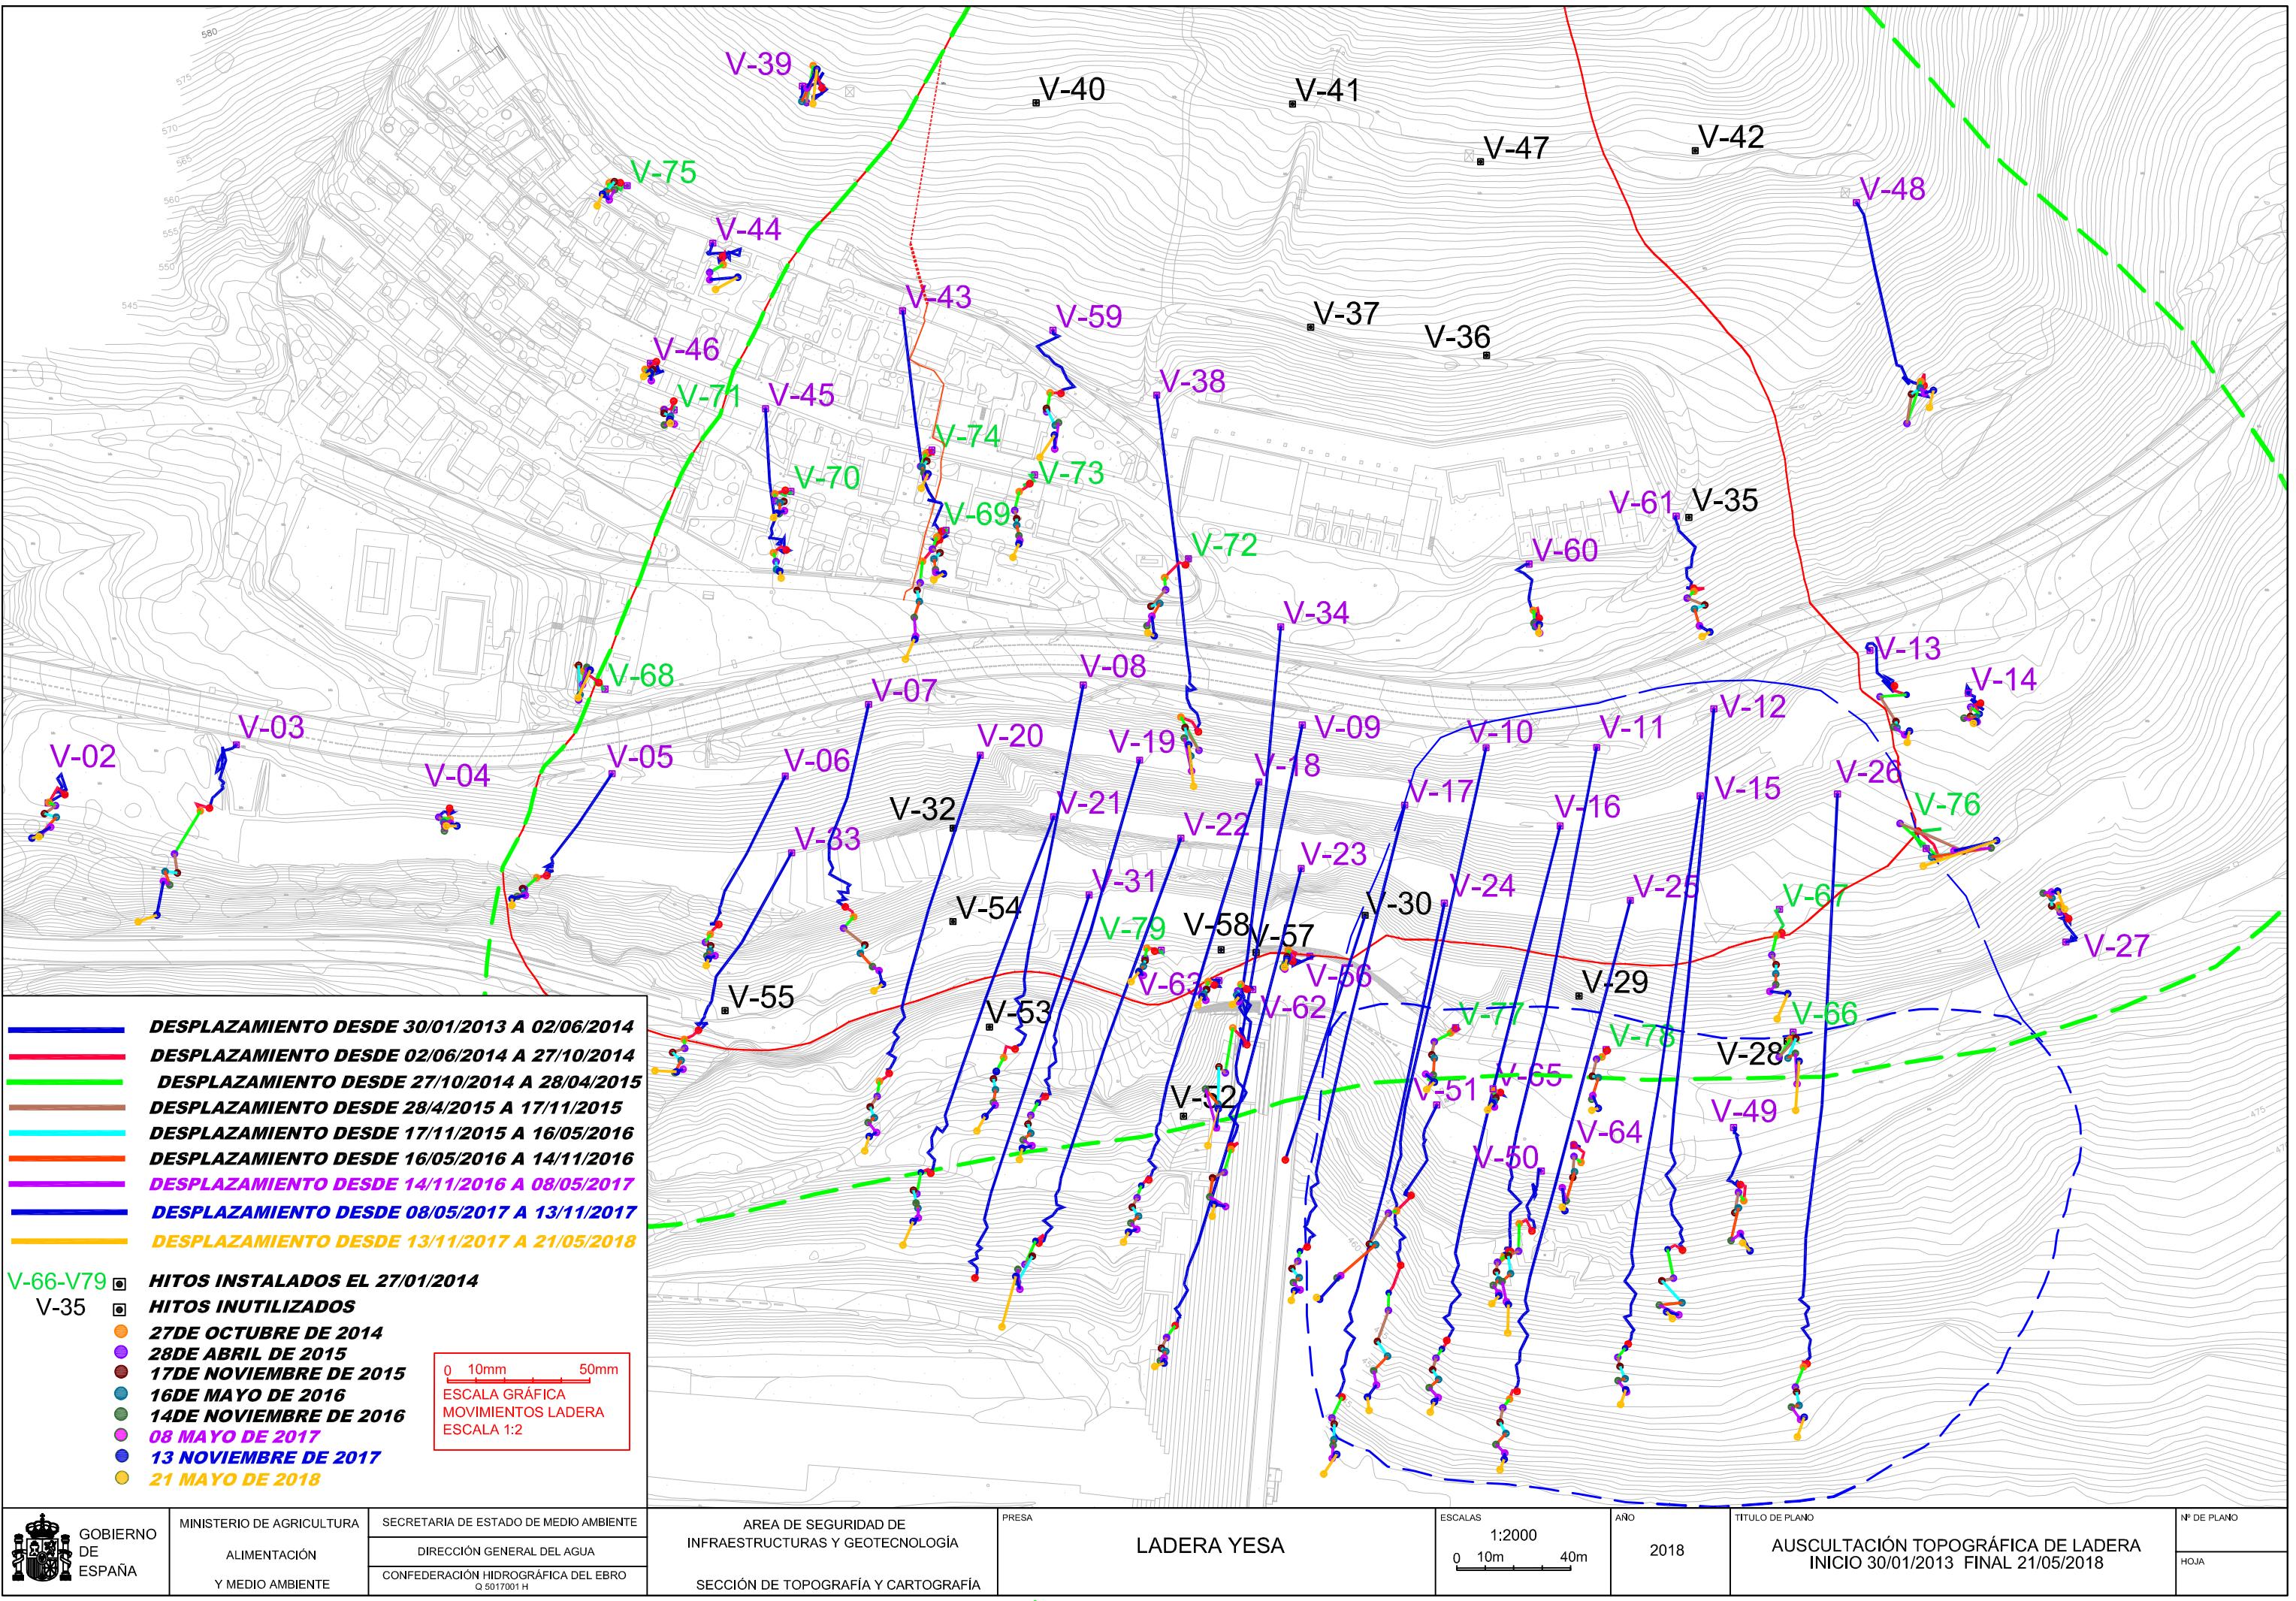
ANEJO Nº 1:
Plano de movimiento de los Puntos de Control Topográfico.

En ambas representaciones se comprueba que el movimiento es insignificante.
