CONFEDERACIÓN  
HIDROGRÁFICA  
DEL EBRO

# INFORME DEL COMPORTAMIENTO DE LA LADERA DERECHA DE LA PRESA DE YESA (NAVARRA). NOVIEMBRE 2015

Zaragoza noviembre de 2015

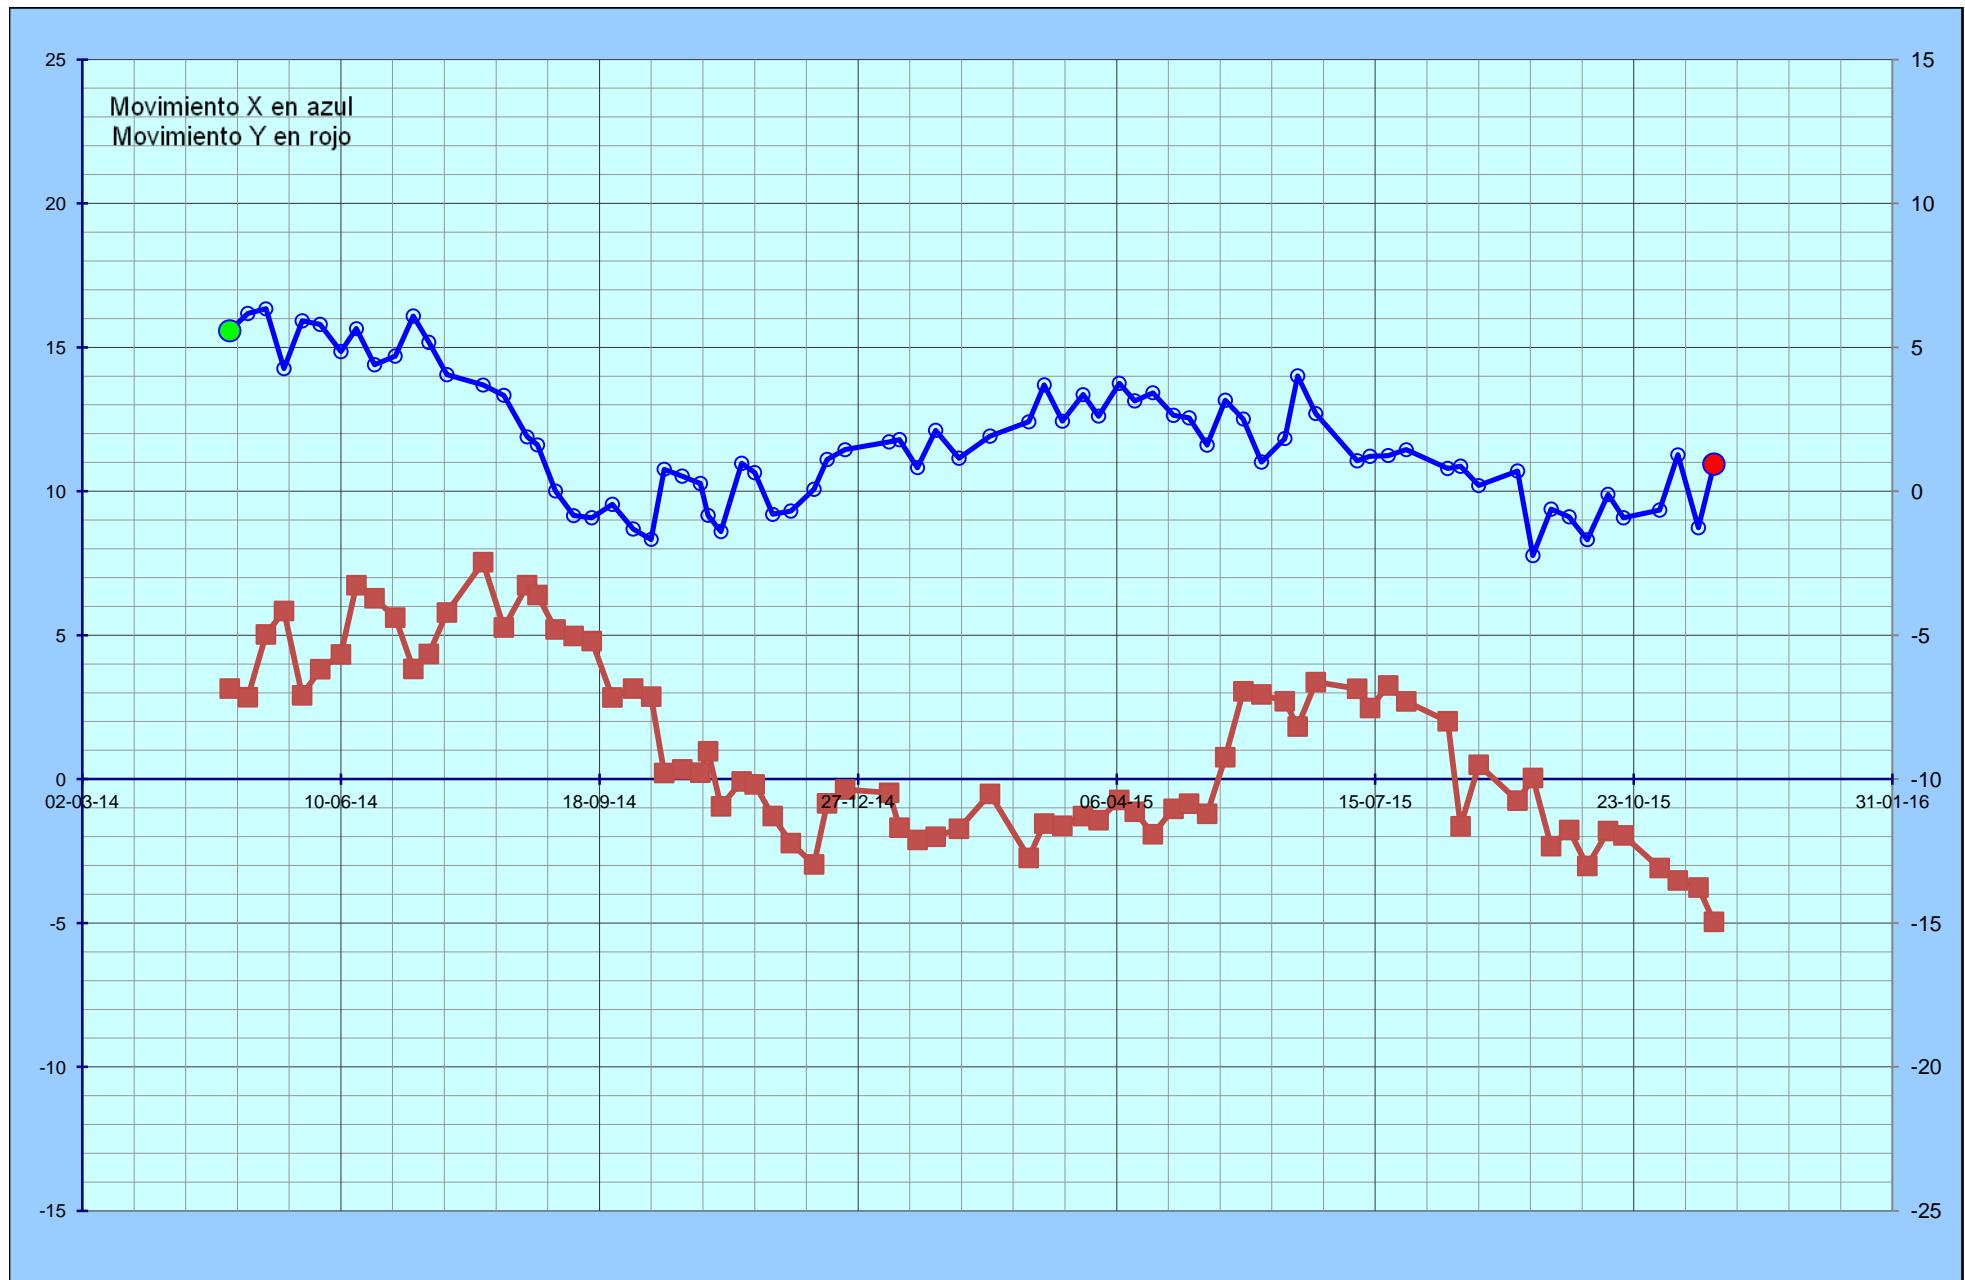
V02

Movimiento XY desde 28-04-2014 (verde) a 23-11-2015 (rojo)
